HUNTINGTON MARINA RESIDENTS' NEWSLETTER

SEA WALL/EROSION LAWSUIT UPDATE PHOTOGRAPHS AND PUBLIC DOCUMENTS REVEAL FACTS

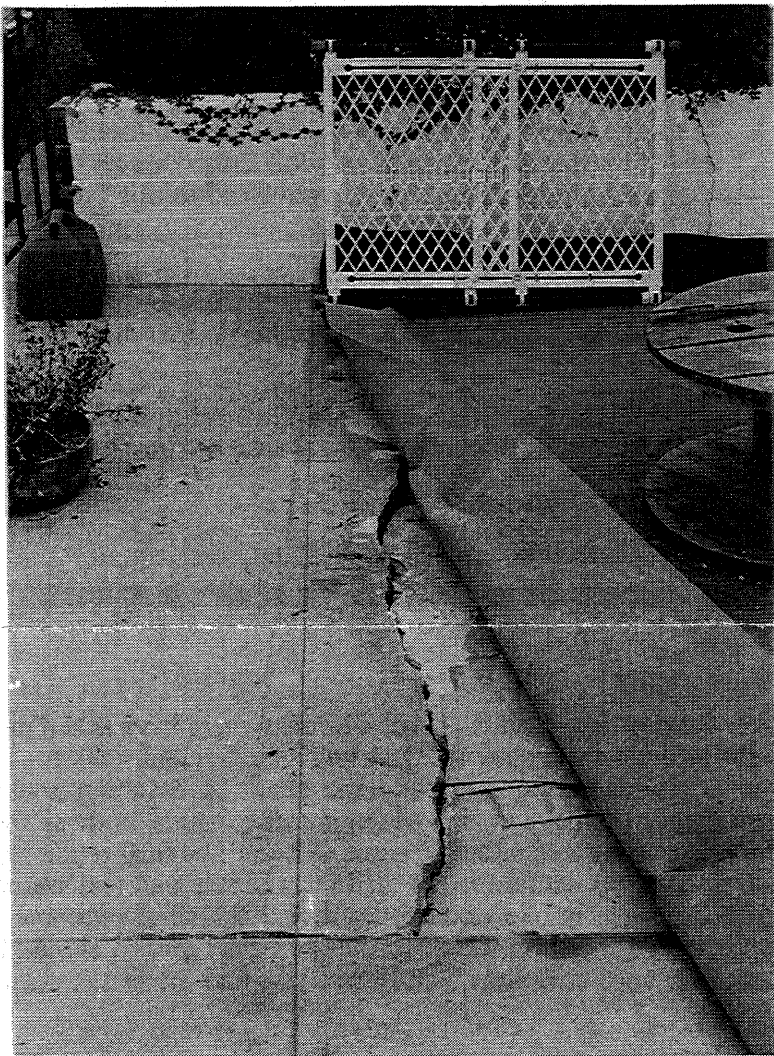
- ⇒ In October 1991, HMA received a report from civil engineer Olen Murrey. The report identified a progressive soil erosion problem and recommended further investigation and repair. Adjacent is one of several photographs of 16088 taken by Olen Murrey, before HMA subsequently covered-up the sinking/cracking patio and breezeway with a cement patch.

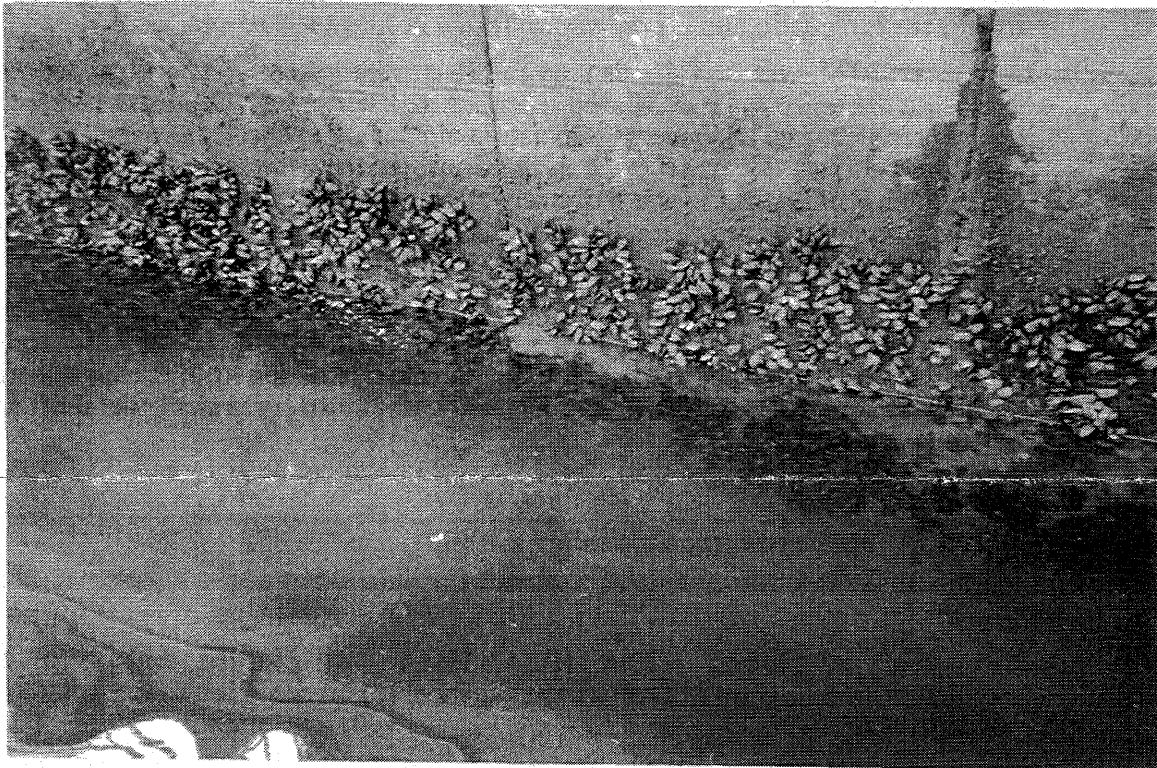
- During the course of the Sea Wall/Patio Committee's investigation, through both consultation with several sea wall/structural engineers and contractors with expertise in sea wall design, construction and maintenance, as well as our own direct observations, we discovered the cause of the patio subsidence problem: **Soil was eroding out through the joints between the vertical cement slabs that make up the sea wall. The sea wall joints (which occur about every four feet laterally between vertical cement sections) were allowing sand and soil to erode out through the joints each time the tide came in and then went out.** The following photograph shows soil eroding out through joints in the sea wall at 16088:

- In 1995, the Sea Wall/Patio Committee provided a report to HMA's Board of Directors. Based on consistent input from numerous sea wall/structural engineers and contractors with expertise in sea walls, the report recommended that certain remedial action be taken by HMA. Recommended repairs included sealing of the sea wall joints using a low pressure grouting process and refilling/recompacting the soil underneath the patio to sufficient levels. Total repair costs were estimated at approximately \$4,000/patio, based on bids received from contractors. The low pressure grouting process is a routinely-used method of repairing sea walls and has been used successfully at several other locations within Huntington Harbor and elsewhere.

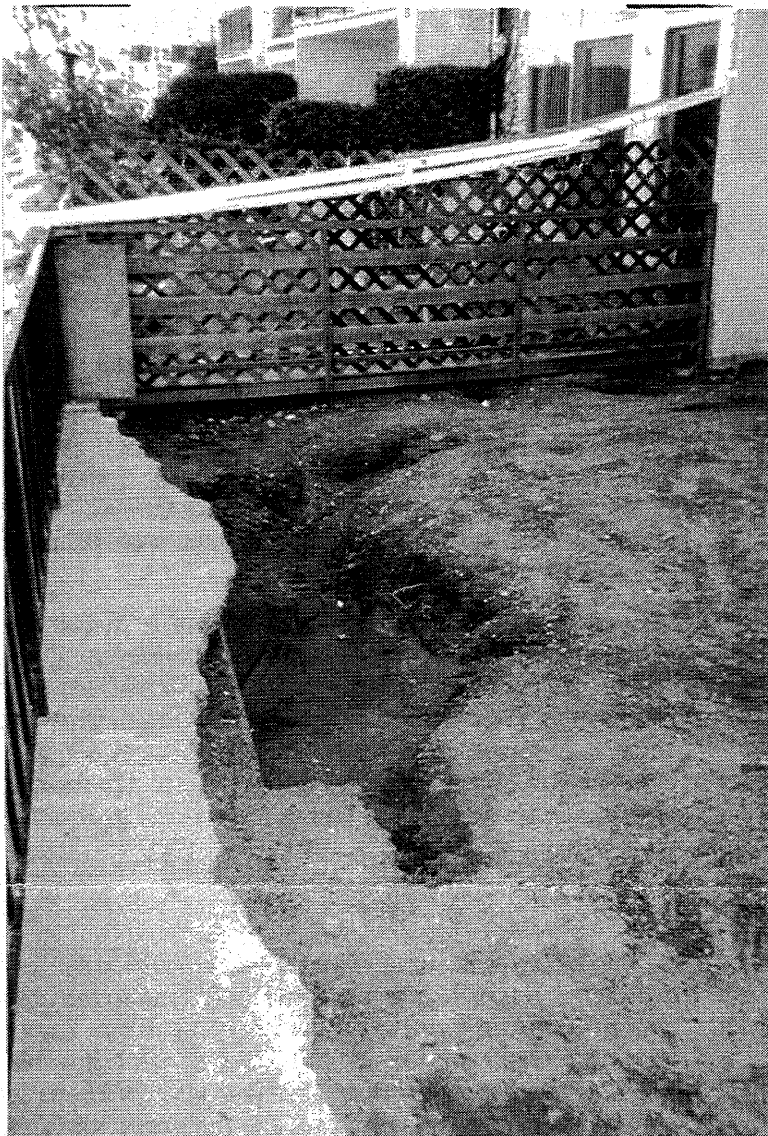
- In April 1996, HMA demolished and removed the concrete patio slab, planter boxes, plants/hedge and fences at 16088. HMA indicated it planned to use 16088 as a "prototype" to see what could be learned about the problem and to develop a repair plan that could be used throughout the remainder of the complex. The large void and soil erosion was confirmed (see the adjacent photograph) when HMA removed the waterfront patio. It progressively worsened as HMA left the patio exposed:

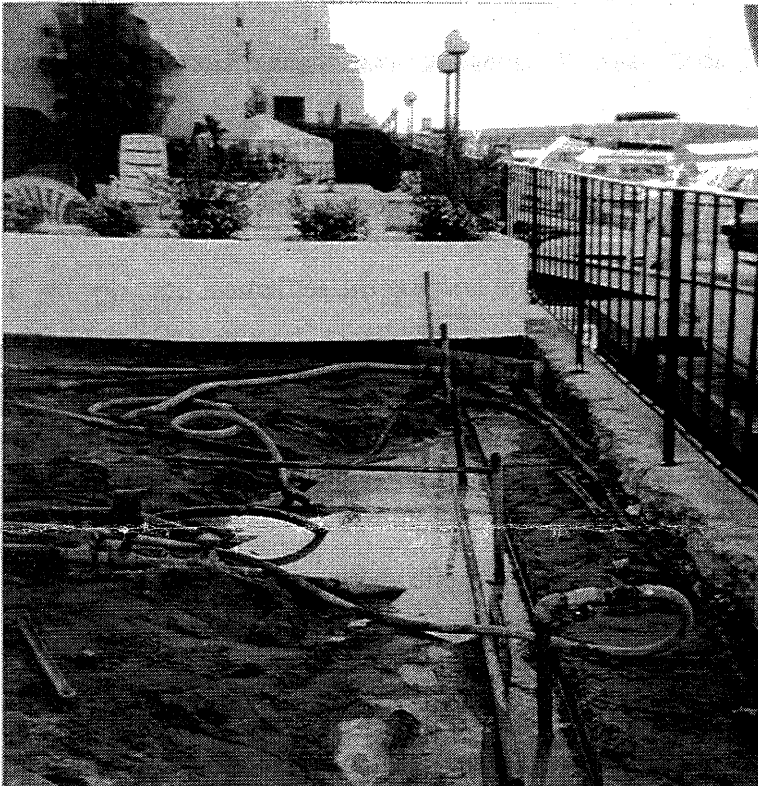
As the contractor installed the pipes, he pointed out several large cavities in the soil along the sea wall, 3-5 feet below the surface. He referred to this as "bridging" of the soil and explained that the size of the surface void is not a reliable indicator of the magnitude of the erosion problem because there can be large voids underneath. He also explained that the waterfront patios crack because of a loss of soil and associated reductions in soil compaction. **The contractor pumped a cement slurry (fly ash) mixture through each of the 15-foot deep pipes until all the voids and joints were filled the entire height of the sea wall.** The grouting is permeable to water but prevents soil loss through the sea wall interlocks. The adjacent photograph shows the sea wall grouting procedure in progress:

Next, a licensed, sea wall grouting contractor installed 15-foot deep grouting pipes at every sea wall joint in front of 16080, 16088 and 16092. Sealing of the sea wall joints at both units adjacent to 16088 was

Next, the contractor installed 15-foot deep grout pipes along the building foundation of 16088. A cement slurry mixture was pumped through each of the five pipes in order to fill any voids in the soil beneath the foundation and to ensure structural integrity of the building.

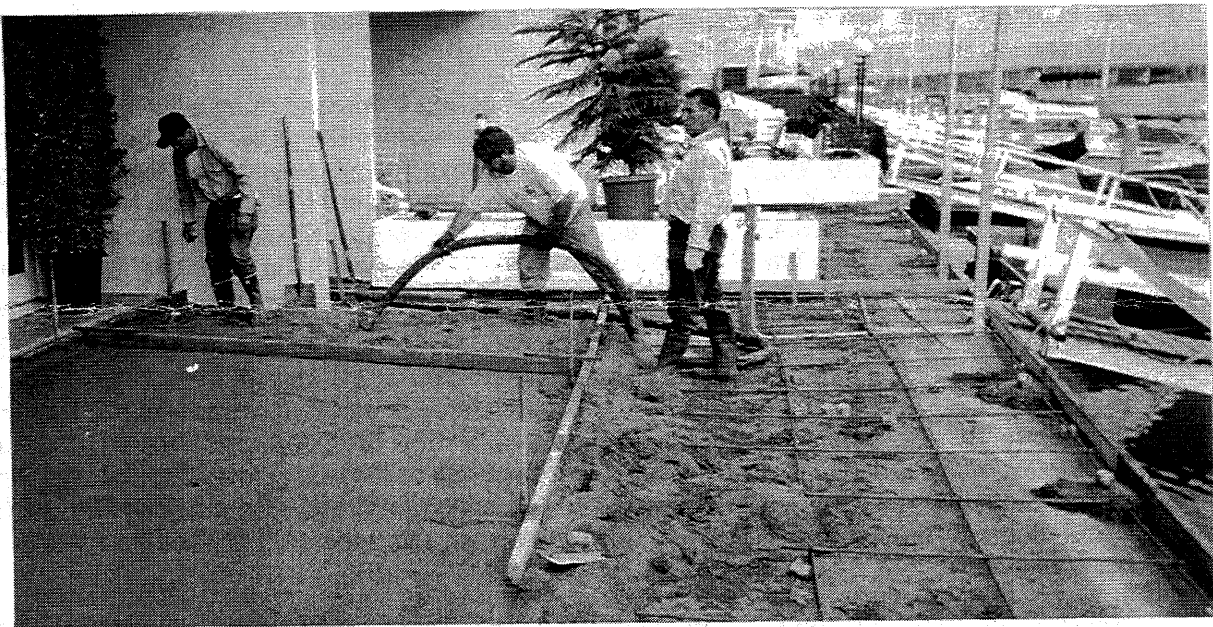
The soil at 16080, 16088 and the breezeway in between was re-compacted to 90% (in accordance with building codes). New patio slabs and a new breezeway slab were installed at 16080 and 16088 by a licensed contractor. The 4" slabs were reinforced with steel rebar, and they are sloped to drain properly. Lastly, the planter boxes, fences, gate and plants were restored.
